## New Building Inspection Report - Frame Stage

Type of Report: New Building Inspection - Frame Stage

New Building Inspection Report - Frame Stage

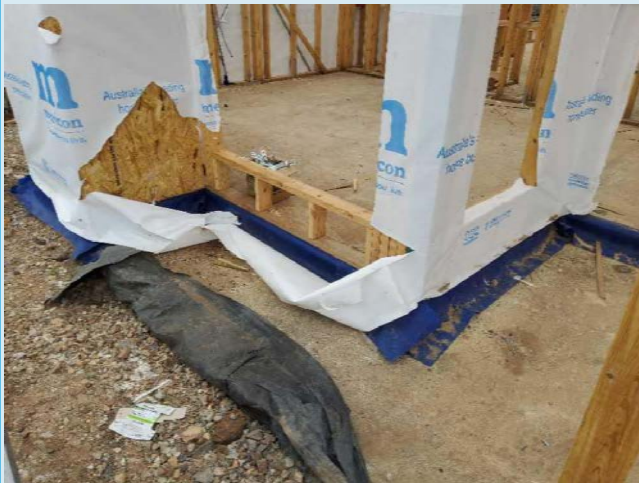
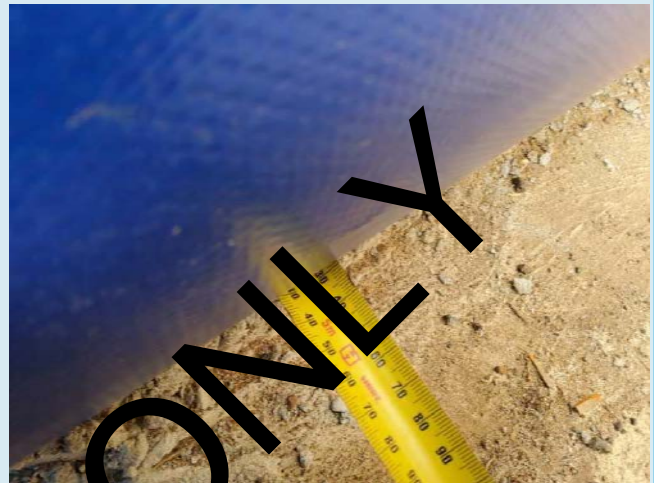
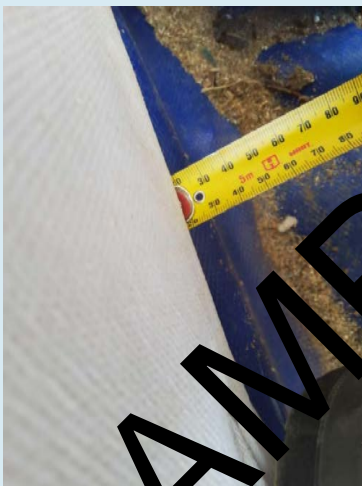
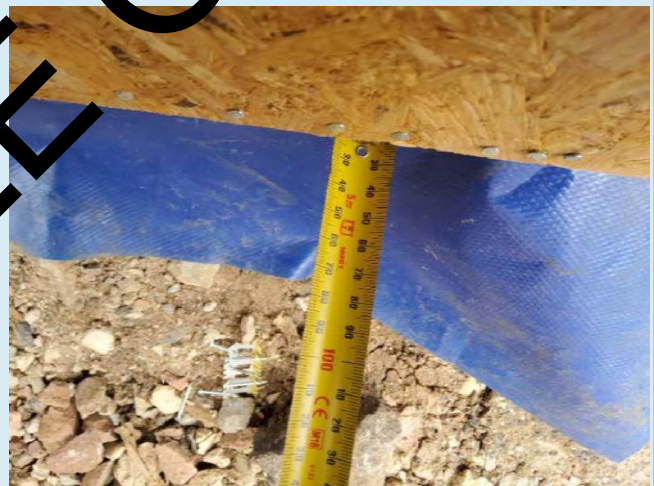
Slab

Some wall frames overhang the concrete slab edge by more than 10mm. As per VBA Guide to Standards and Tolerances, "4.08 Bottom plates that are 90 mm wide or greater and overhang concrete slabs by more than 10 mm are defective." Rectify the slab edge with non shrink grout (or another method as specified by the engineer) to support the bottom wall plate edges.  
I.e. walls around the front porch up to 25mm overhang.

**A mostly good framing setup. Some reinforcing is needed for the concrete slab edge to support framing overhangs. Several framing members and bracing need additional nailing to secure into position.**

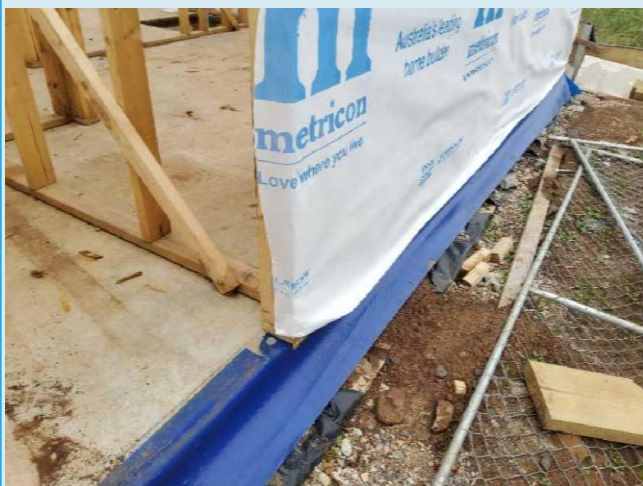
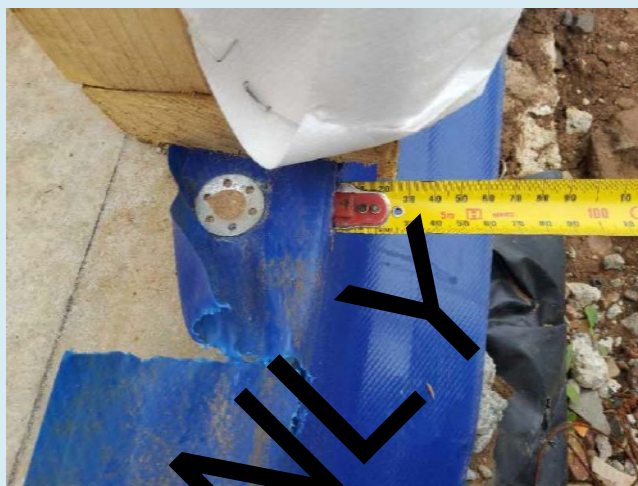
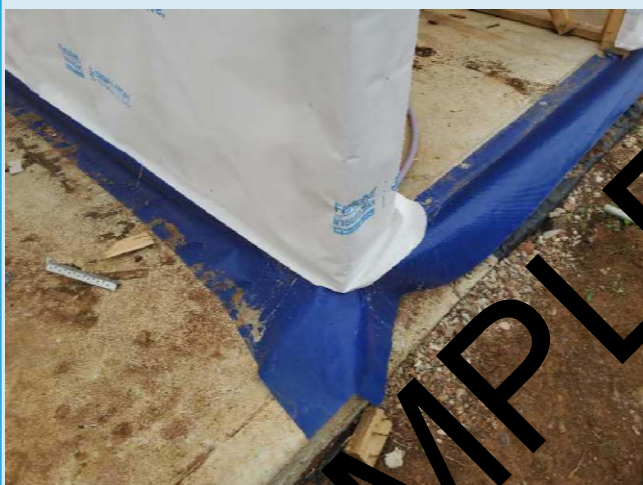
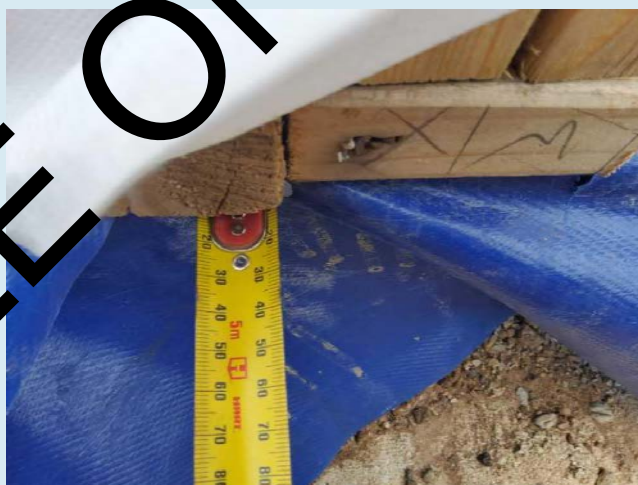
Slab

As above, the rear wall at the laundry door opening, on both sides, up to 20mm is overhanging the slab edge.

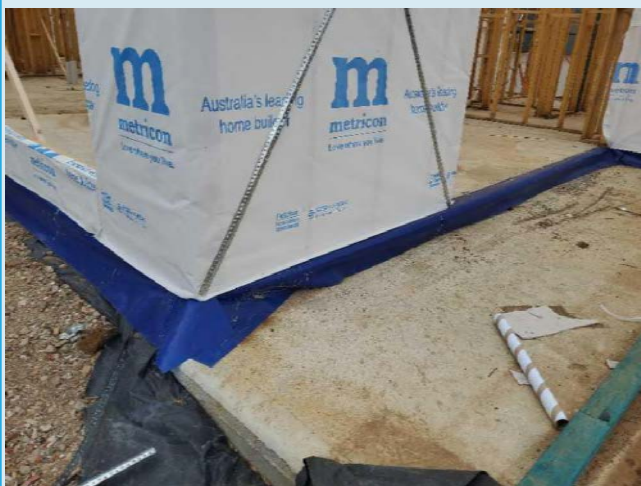
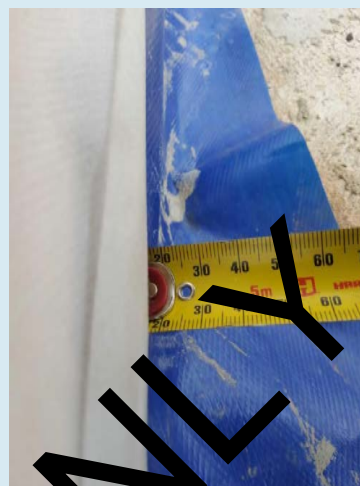
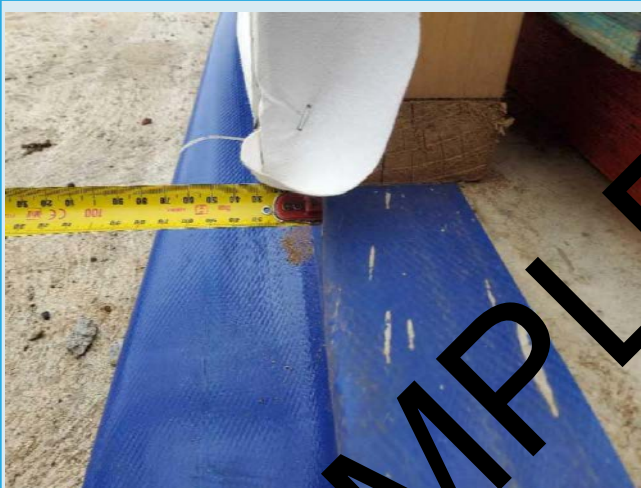
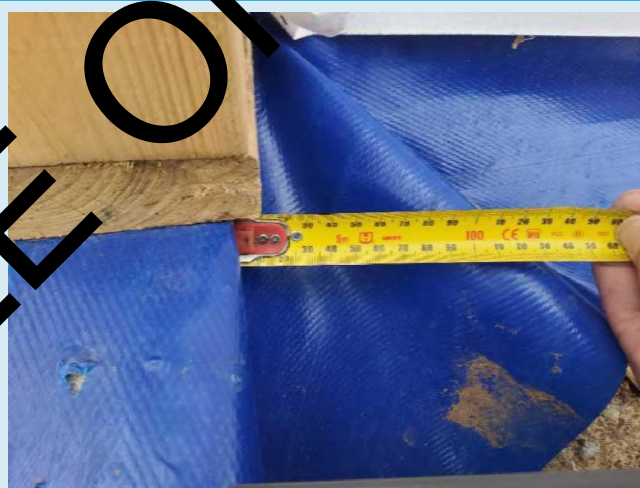
**Slab**

As above, the rear wall of the living room, up to 25mm is overhanging the slab edge.

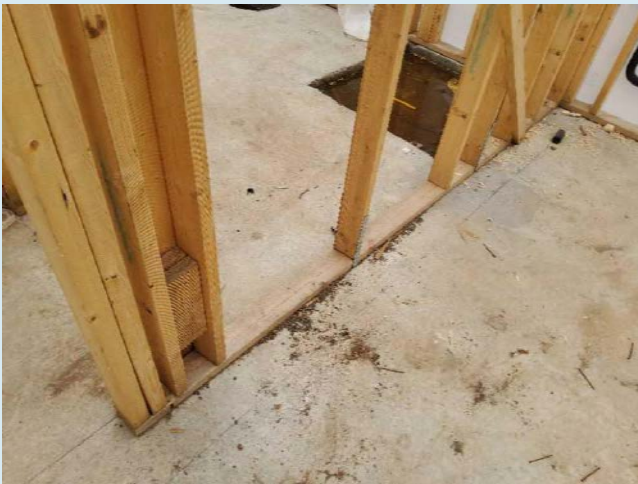
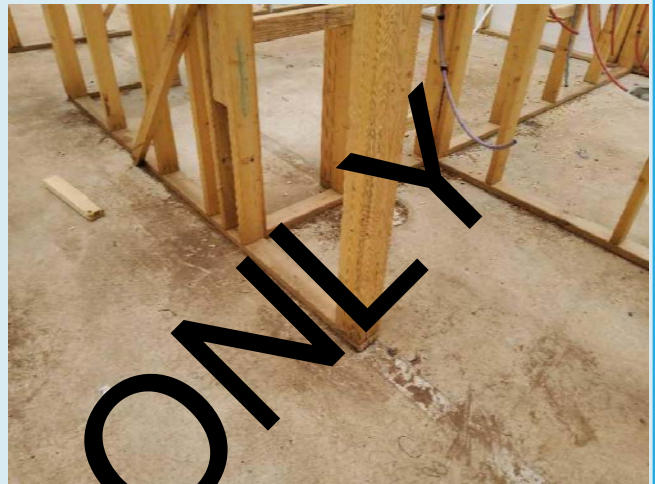
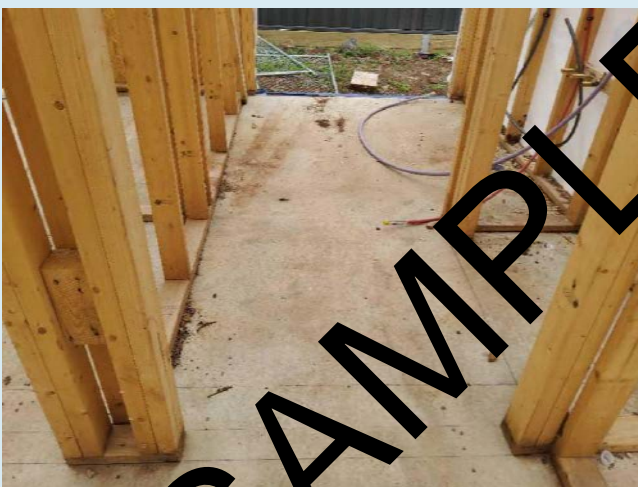
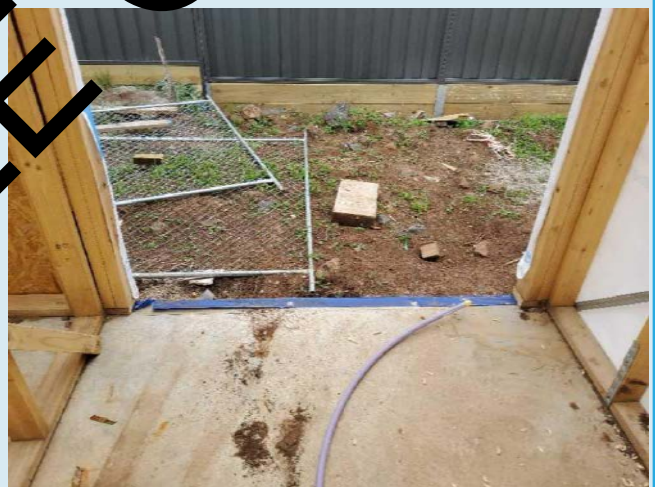
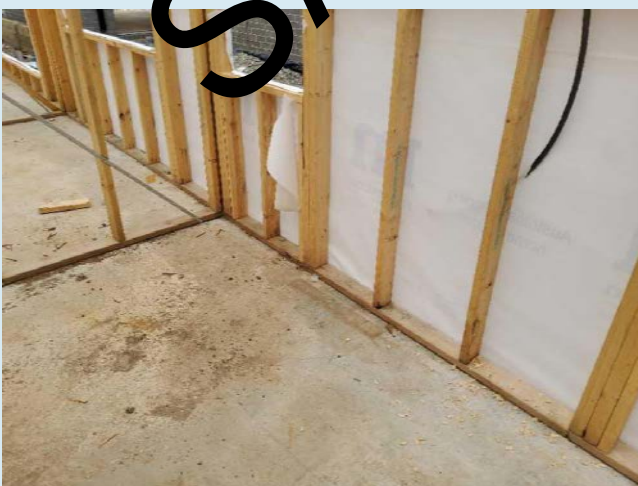
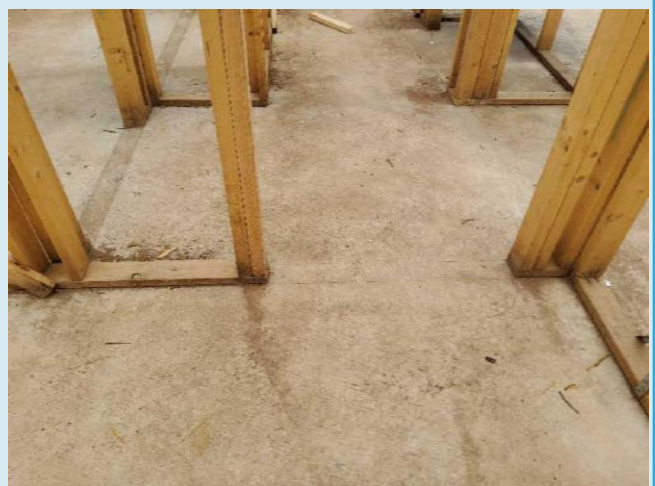
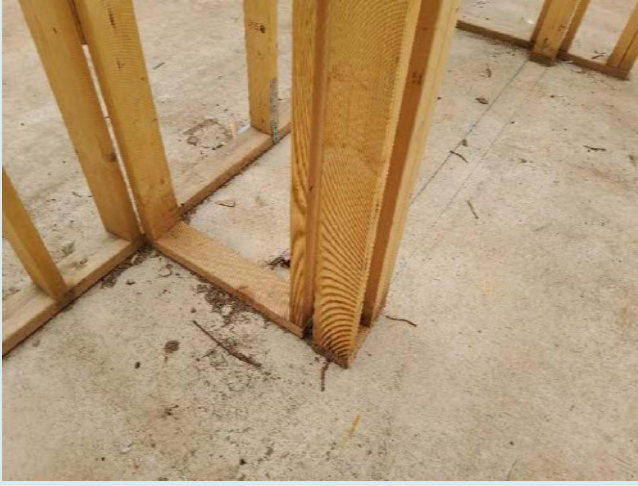
Walls

- Bottom wall plates are loose in some places and need further nailing to the concrete slab, i.e.
- rear bedroom front wall,
  - hallway, at powder room door opening,
  - Laundry door openings, internal door, and external doorway,
  - Left side wall,
  - Bed 2 doorway,
  - Bed 2 robe

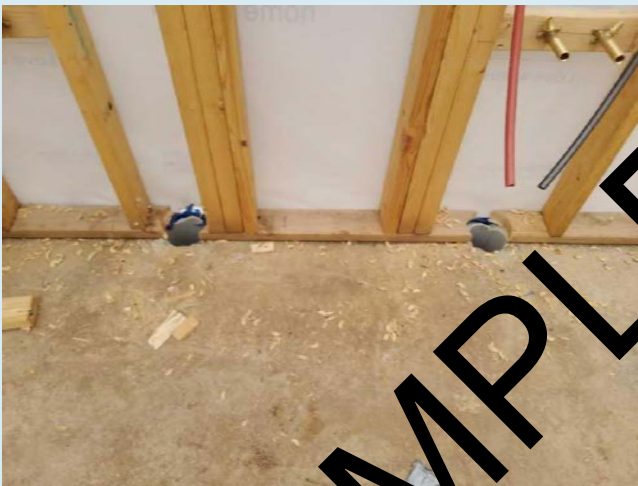
Walls

Bottom wall plates need reinforcing metal strips where cut for pipe penetrations i.e. Ensite

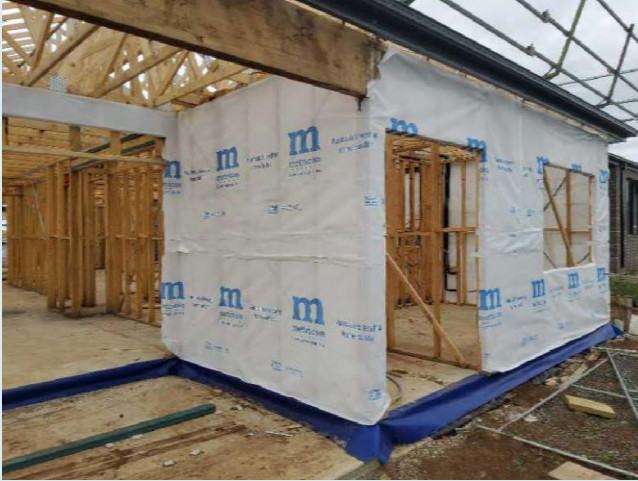
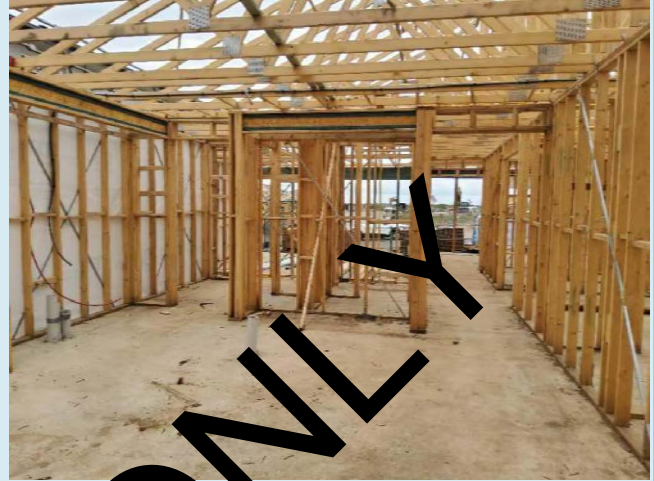
**Bracing**

Sheet bracing and metal strap bracing are installed and have been covered by wall wrap in some places so nail fixings are unable to be checked. Most bracing appeared fine where visible.

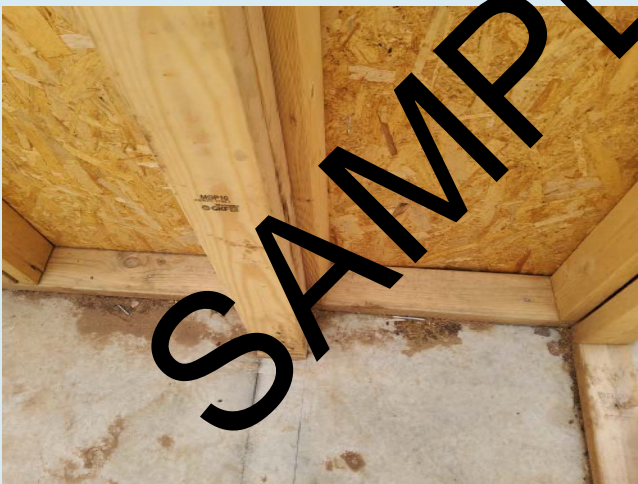
**Bracing**

A brace board at the rear of Bed 4 is loose at the lower nailing and needs nailing off.

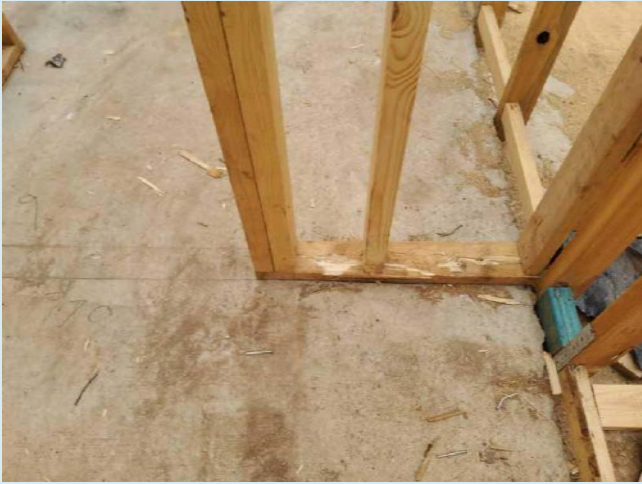
<b>Walls and Structural Beams inspection</b>	
<b>Minor and/or Major Defect</b>	<b>Walls</b>
<b>Comments</b>	
The butler's pantry bottom wall plate is split and needs reinforcing.

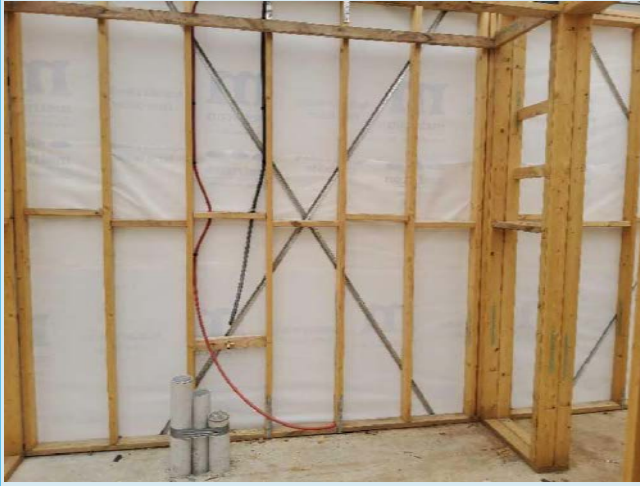
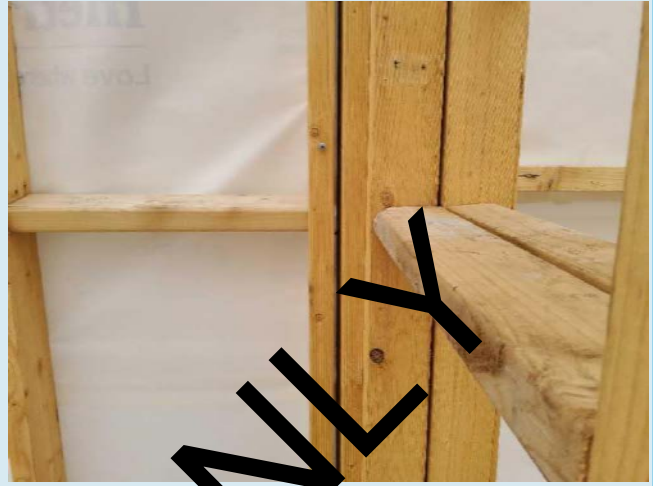
<b>Walls and Structural Beams inspection</b>	
<b>Minor and/or Major Defect</b>	<b>Walls</b>
<b>Comments</b>	
Butler's pantry and kitchen- 2 doorway bottom wall plate and studs are inadequately connected and need to be nailed off.

<b>Walls and Structural Beams inspection</b>	
<b>Minor and/or Major Defect</b>	<b>Walls</b>
<b>Comments</b>	
Kitchen right side wall - Install nogging between double studs gap.

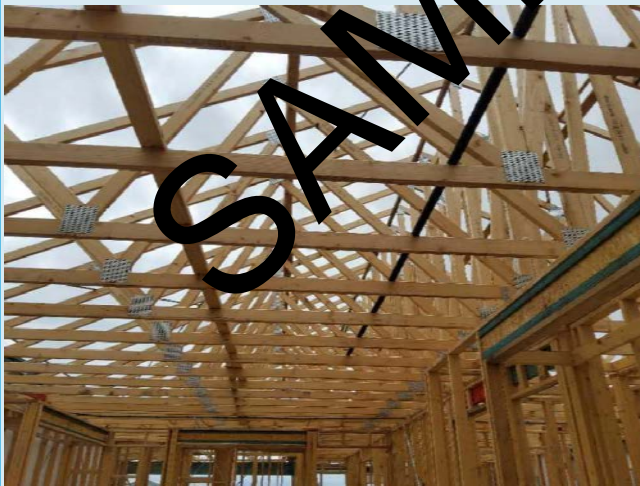
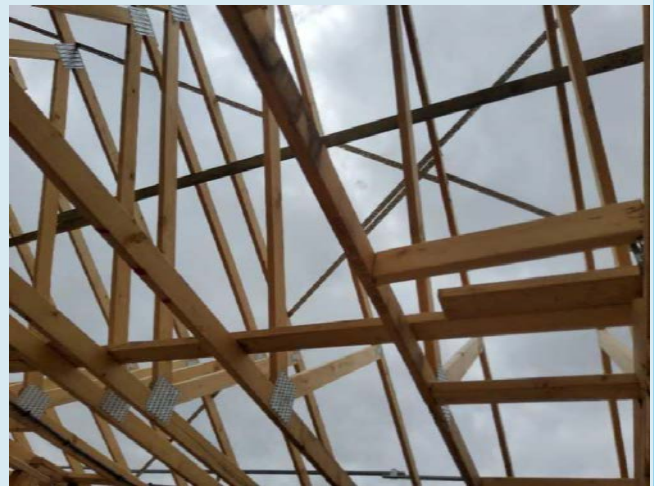
Trusses/Layout

The truss setup appeared fine.

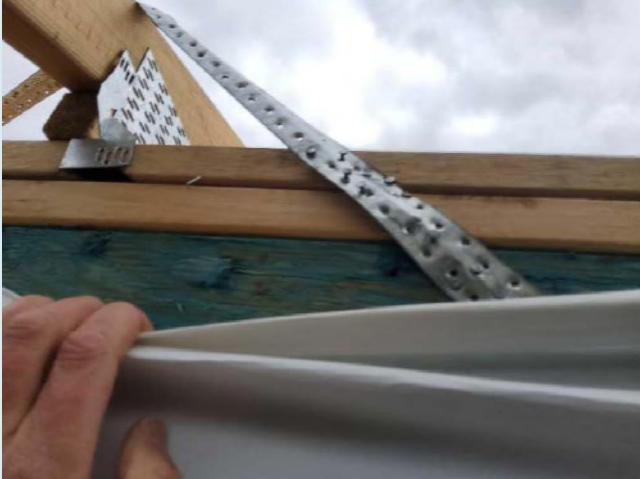
Roof inspection	
Minor and/or Major Defect	Bracing
<b>Comments</b>	
Bracing nailing was mostly covered by wall wrap. Bracing nails were loose at a left side wall. Recommend the site supervisor check all bracing nailing and ensure adequate.
